Asset Inventory and Capital Improvement Plan

TOWN OF COLLBRAN

October 2020

SGM Project # 2019-327.001

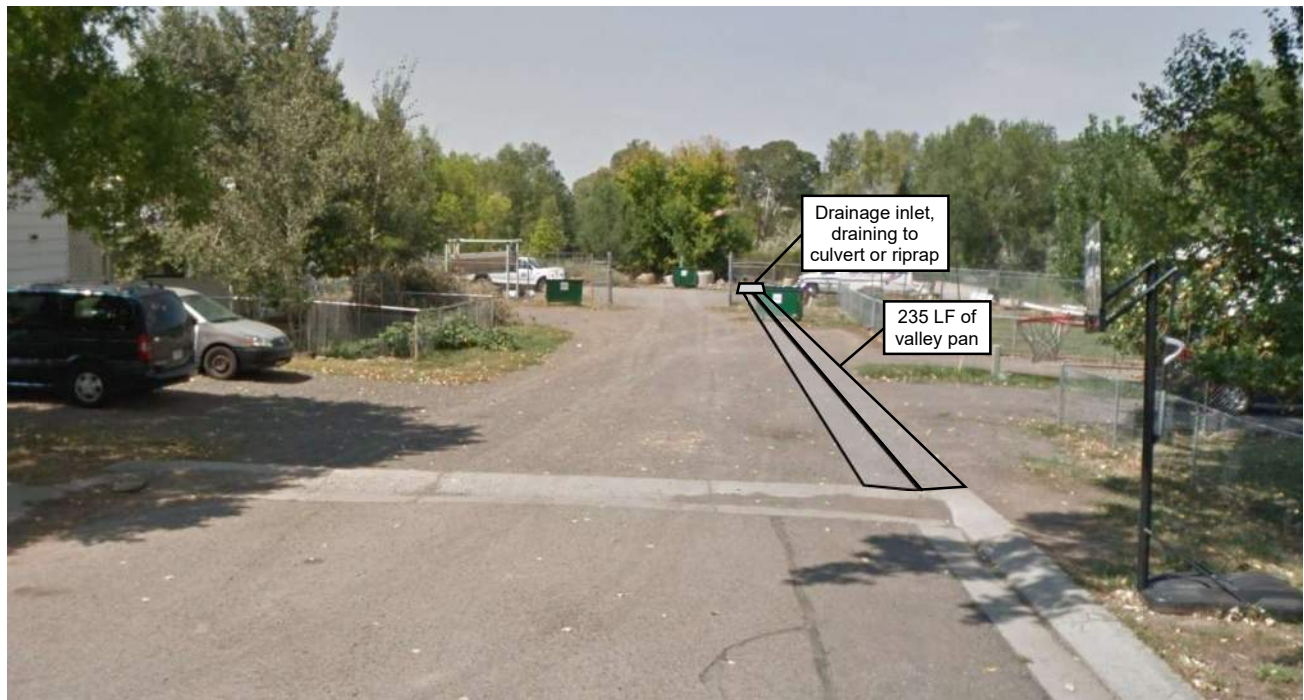
Figure 2-1. Proposed Stormwater Improvements at Pinion Street and Poplar Court

Overall, the Town's stormwater management infrastructure appears adequate. There is one known location with poor stormwater control near the intersection of Pinion Street and Poplar Court. The valley pan and gutter drainage in this area terminates without a proper drain to the creek, resulting in improper drainage during rain and runoff events. In addition, a drainage issue at the bridge along High Street and Orchard Avenue has been noted and is slated to be remedied by the State.

It is recommended that improvements be made to the drainage at the intersection of Pinion Street and Poplar Court. These improvements include approximately 235 LF of concrete valley pan running into the Town's lot at the end of Pinion Street, a drainage inlet, and 25 LF of culvert or riprapped swale providing an outlet to the adjacent stream. Figure 2-1 shows the proposed improvements.

1.	<u>Pinion Street Stormwater Improvements:</u>	
	-235 LF valley pan	\$ 10,000
	-Drainage inlet, culvert, outlet	\$ 7,500
	Cost estimate:	\$ 17,500

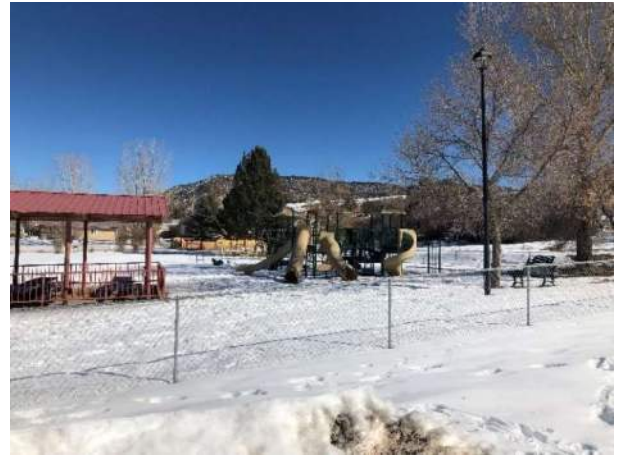
Terrell Park is in good condition. The playground equipment is estimated to be 20+ years old but appears in good shape with years of useful life yet. The pavilion appears structurally sound with no visible deficiencies. The bathrooms have flat roofs with skylights. The skylights show signs of leaking. Fixtures in both the mens and womens rooms are in good condition.

It is recommended to replace the flat roof with a pitched roof to allow snow and rain to drain off. The skylights should be replaced at the same time. No lighting is present at the bathroom facilities, it is recommended that motion-detector exterior lighting be provided for safety and security. Yearly assessments of park components are recommended.

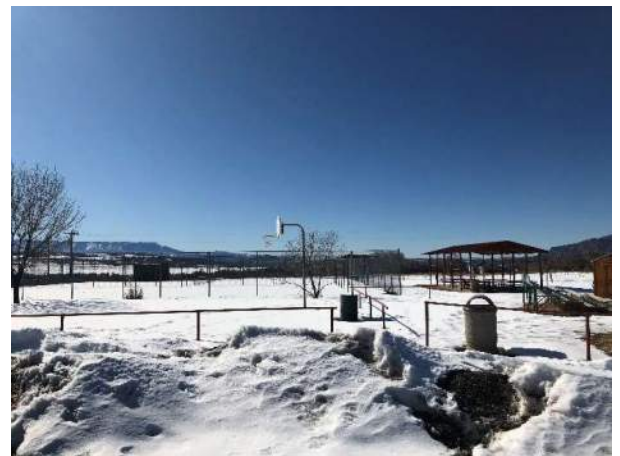
Most of Gandhi Park is in good condition. The pavilion appears structurally sound with no visible deficiencies. The bathrooms have flat roofs with skylights. The skylights show signs of leaking. Fixtures in both the mens and womens rooms are in good condition. Town staff noted that the two tennis court surfaces have degraded and could use resurfacing.

It is recommended to replace the flat roof with a pitched roof to allow snow and rain to drain off. The skylights should be replaced at the same time. No lighting is present at the bathroom facilities, it is recommended that motion-detector exterior lighting be

provided for safety and security. Yearly assessments of park components are recommended.

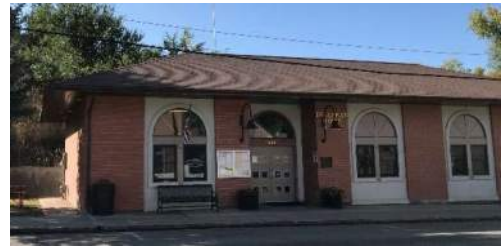
- b. Discussion:
 - i. Roofing on the south side of the building is metal panel roofing, reportedly replaced 6 to 7 years ago. The remainder of the roofing consists of composite shingles that appear quite worn and degraded and likely near the end of their useful life. Replacement of the composite shingle roofing with metal panel roofing similar to the south side is highly recommended.

- ii. Gutters and downspouts have some areas of damage and reportedly leak repeatedly at all seams and corners and cause icing issues on sidewalks during winter weather. Replacement with new seamless gutters and downspouts is recommended.

- iii. Retaining wall on the south side of the building has numerous vertical cracks at the location of plastic weep hole pipes. The cracks do not appear to have affected the structural integrity of the wall but are unsightly.

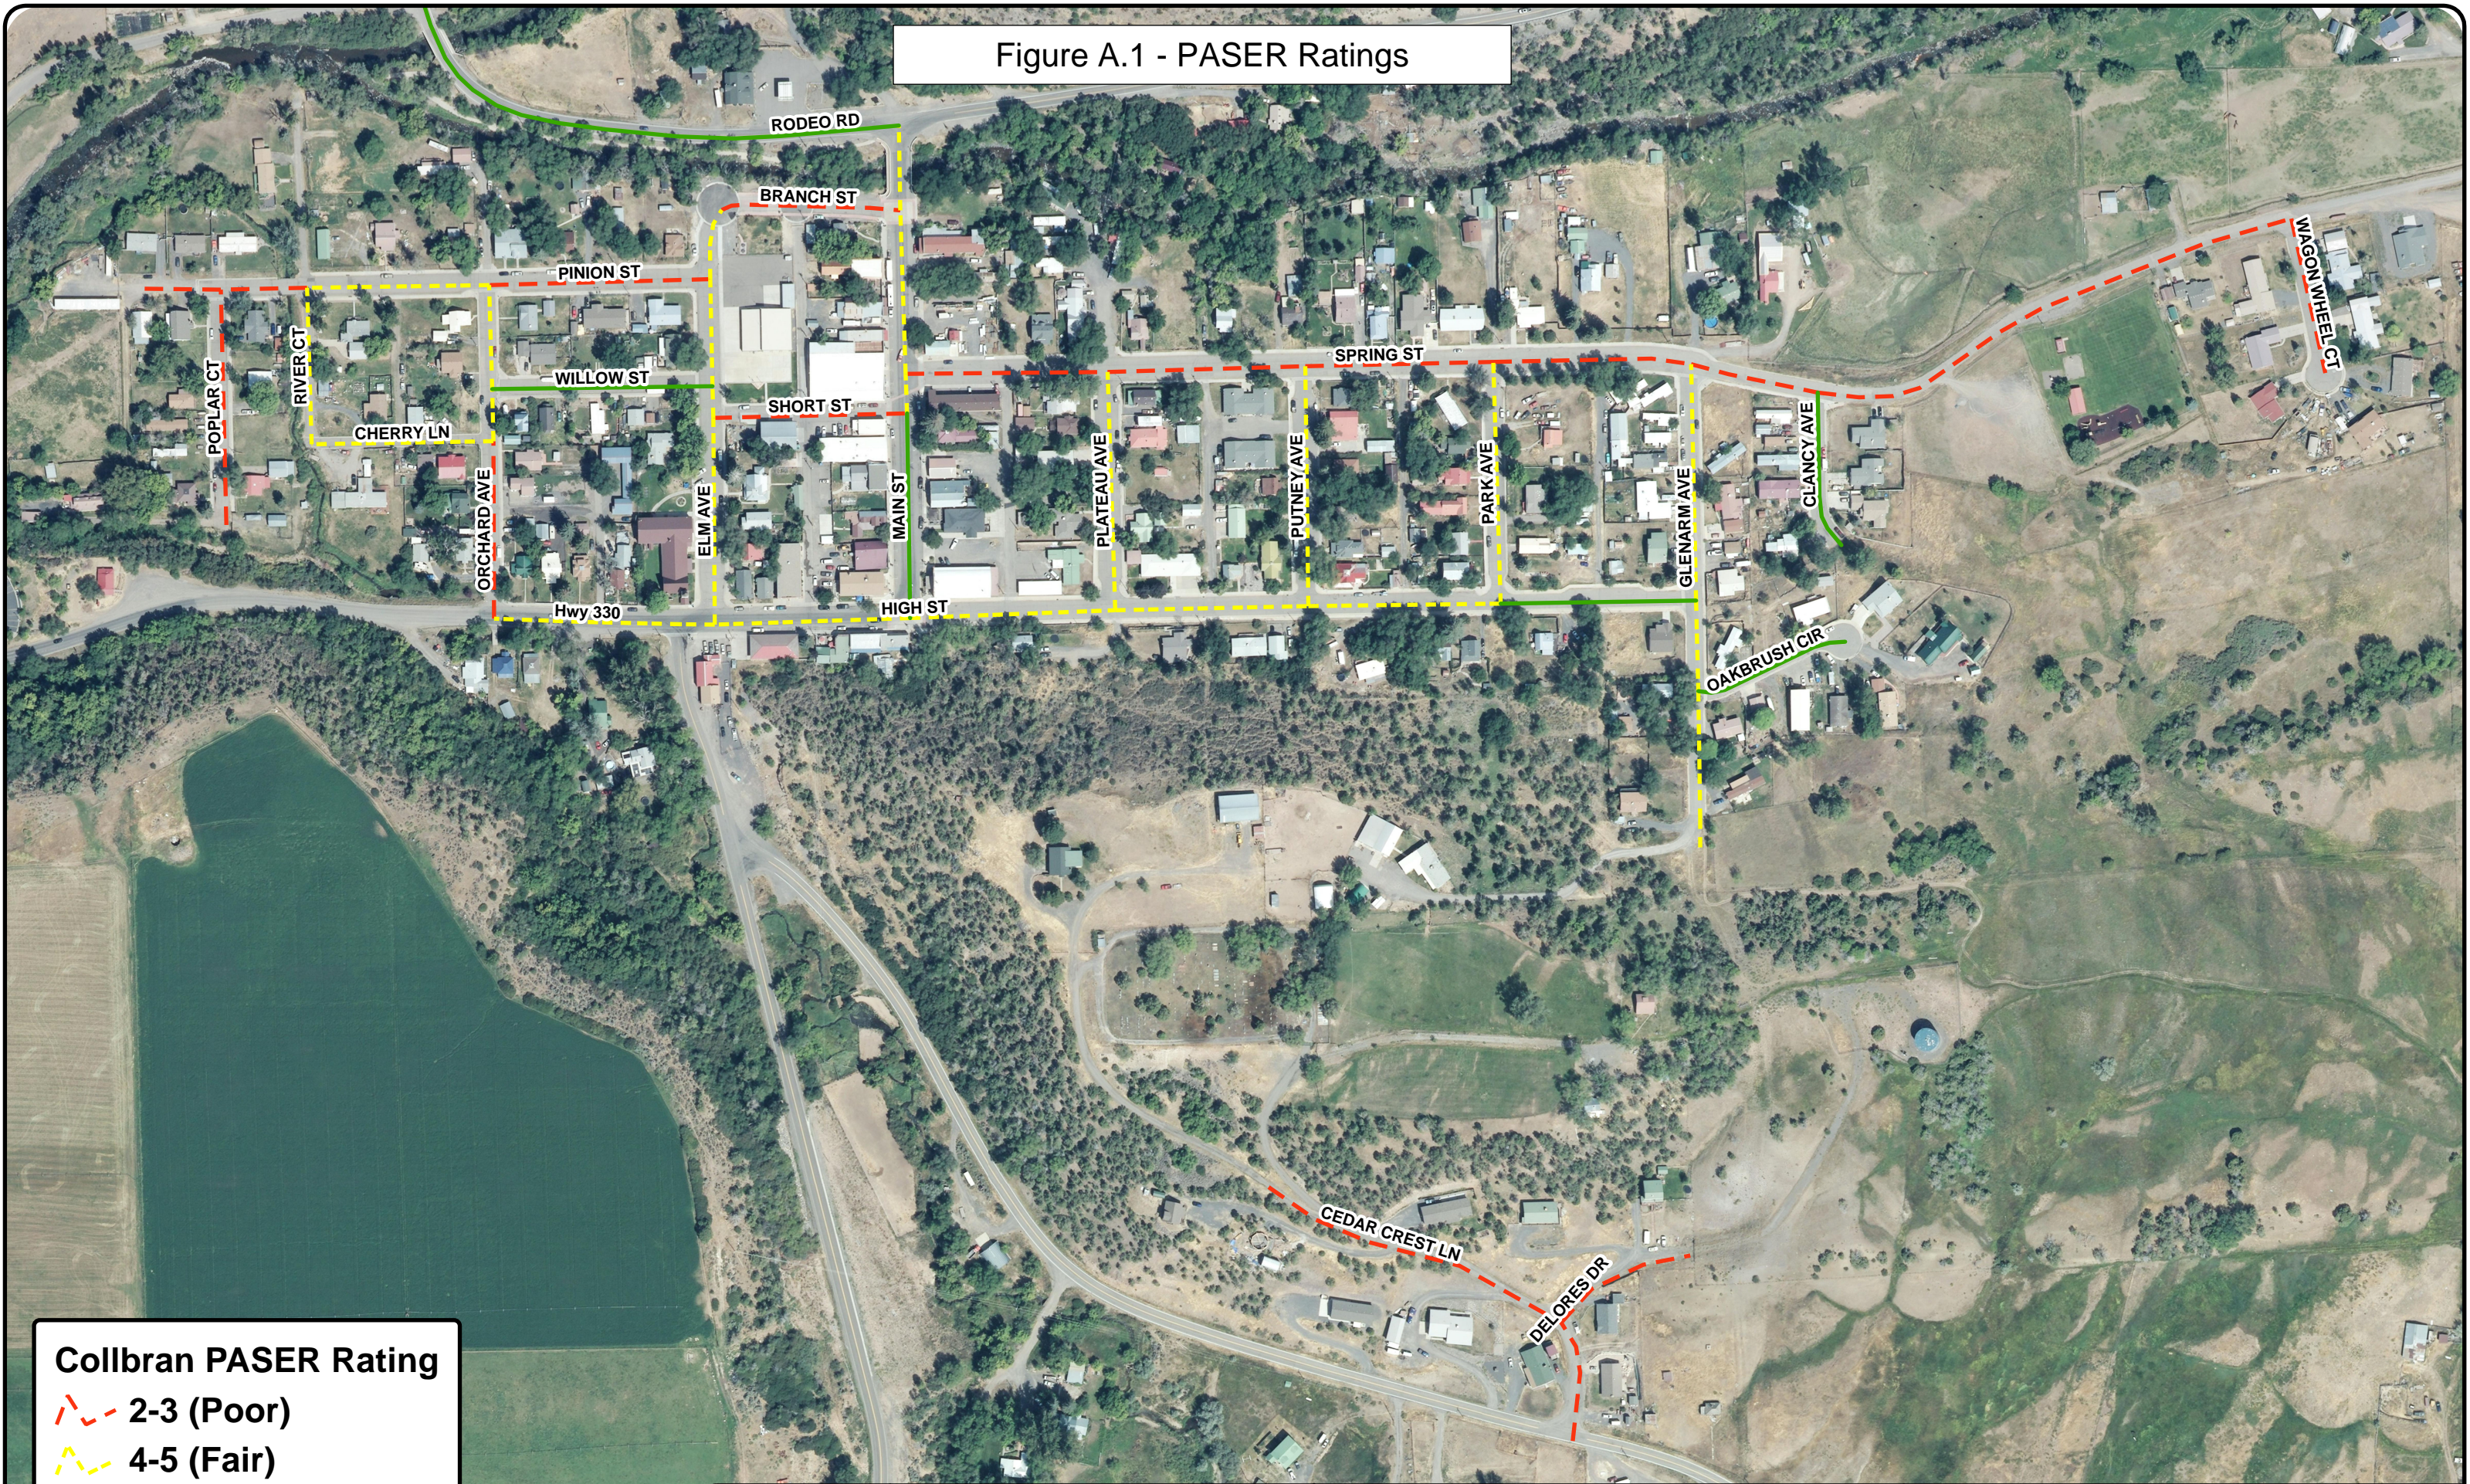
Figure A.1 - PASER Ratings

SGM walked all of the asphalt streets in Town and rated each section which was defined as the segment of road between streets. The PASER system provides a range of ratings, from a 10 for to a newly constructed road to a 1 for roads that have completely failed. Table 2-1 summarizes the condition of the Town's roads; a map of the streets and their ratings is attached in Appendix A as Figure A.1.

Most sections of the roads exhibit moderate to severe surface wear and defects referred to as raveling and polishing.

- Long Term Pavement Plan
Any road from the recent PASER evaluation with a rating of 5 or less should be slated for repaving. A per-year budget for paving operations should be established in conjunction with the Mesa County paving plans.
- Routine Maintenance, Gravel Roads
Gravel/dirt roads should be regraded in the late spring each year to mitigate potholing and washboarding that forms over the previous year.
- Routine Maintenance, Asphalt Roads
Once a road is repaved, chip and seal (chip seal) is recommended to provide a wearing course and significantly lengthen the lifespan of the asphalt. Chip sealing is generally recommended for lower-traffic roads but may be applicable for all of the Town's roads. In addition, crack sealing should be performed each year on asphalt roads to prevent water infiltration and potholing.
