Collbran Auditorium
Historic Structure Assessment
History Colorado State Historic Fund Project #2019-HA-004

July 9, 2019

**102 Main Street
Collbran, Colorado 81624**

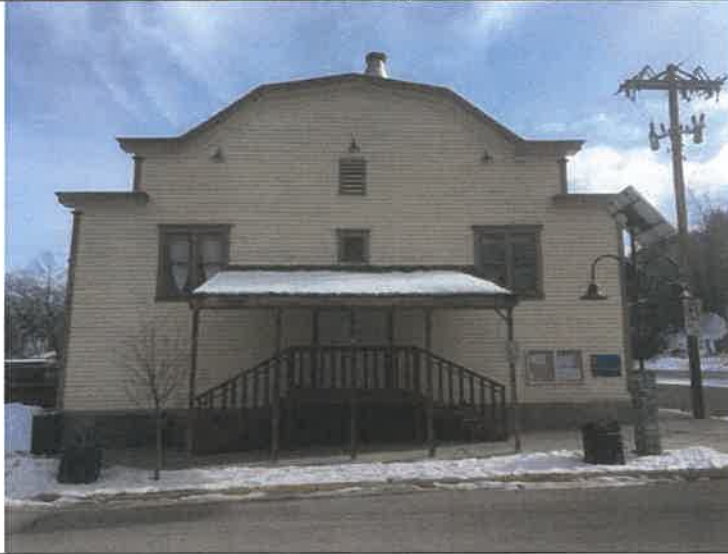
1: West Elevation: the canopy and entry stairs are not original.

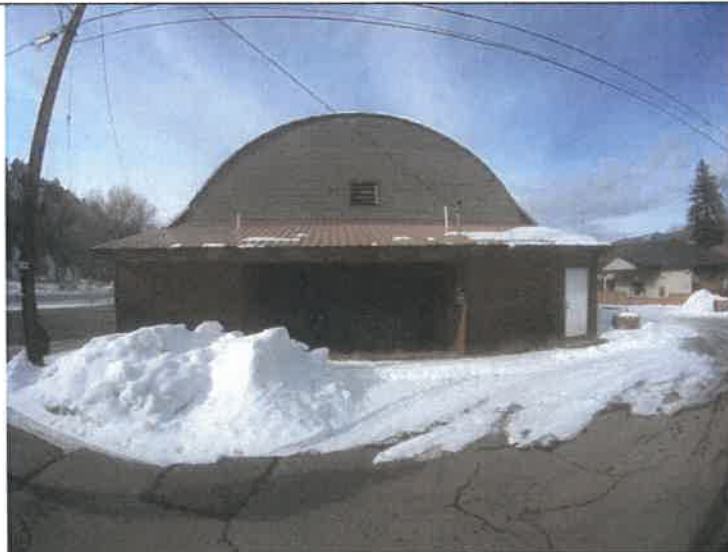
2: East Elevation: the shed roof and T-111 bump outs are not original, the basement is accessed in the east elevation below the shed roof and between the bump outs.

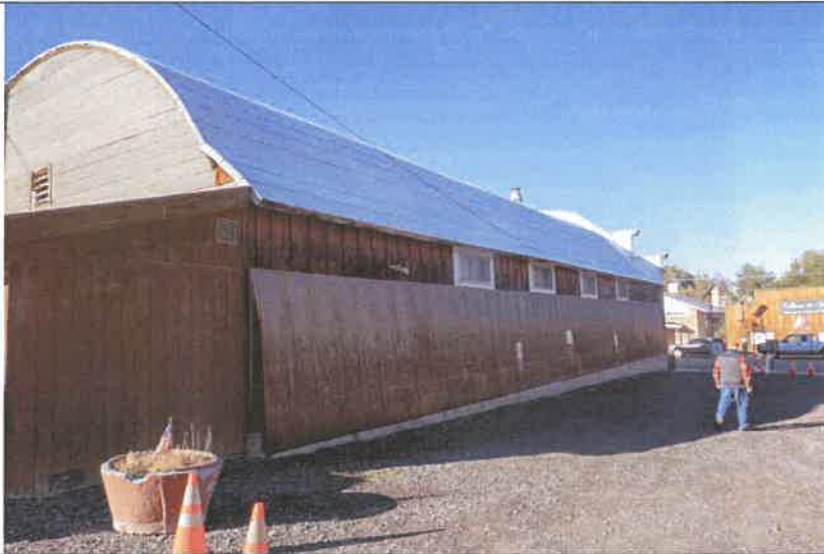
3: North Elevation: the clerestory windows were originally the only portion covered by the secondary roof slope overhang.

The continuous clerestory overhang is not part of the original design as evident by the historical photos prior to 1967 (photographs H1-H5) which show only overhangs above each individual clerestory. Given this fact and its poor condition that may be contributing to water infiltration this continuous overhang should be demolished and re-built to be more historically accurate.

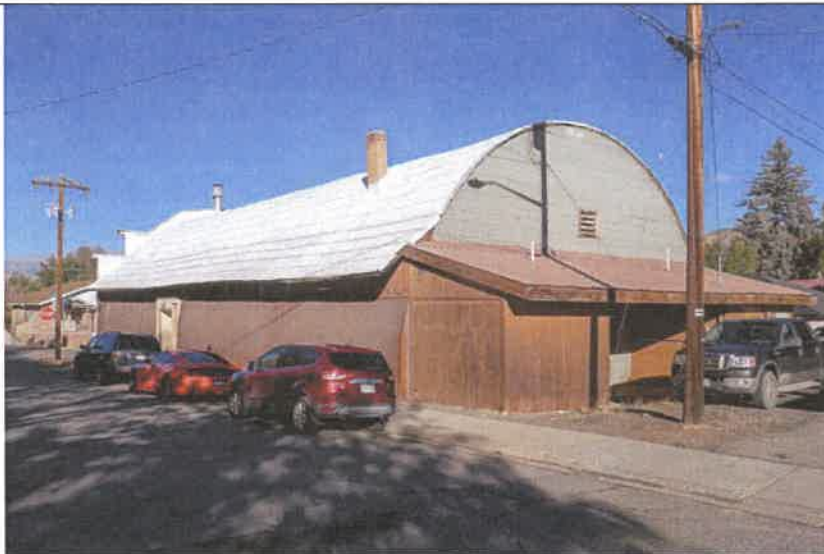
4: South Elevation: the south clerestory overhang extends farther than the north and is visibly bowed.

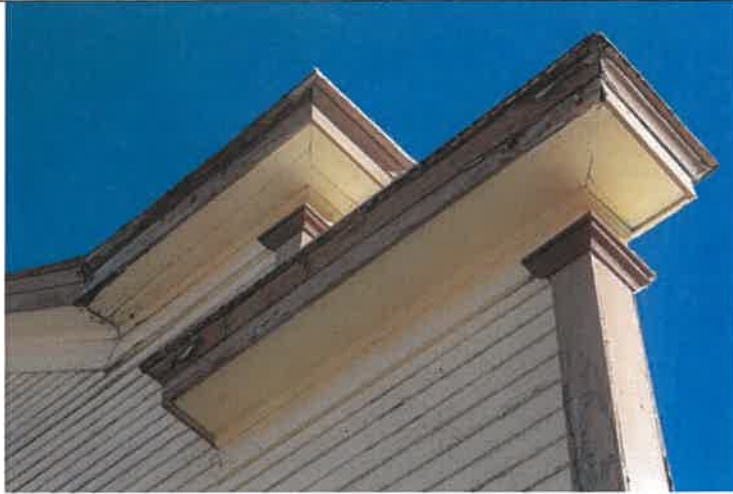
The exterior walls appear to be in fair condition with the exception of the clerestory overhangs which are missing soffit sections, are rather warped and may be contributing to water leakage through the clerestory heads. The west facade wood siding does not show any signs of decay and is in good condition considering its age. The west façade cornice and corner trim is in fair condition

with the majority of molding pieces being salvageable (photographs 5 and 6). The east elevation's cladding also appears to be in good condition but of little historical significance.

5: West façade - south cornice detail.

The west façade contains the building's most detailed historic material in its siding, corner trim and cornice molding and should either be salvaged for restoration or restored in place. The entirety of the west façade should be re-painted based on historically used colors which can be determined from a paint analysis of the existing siding and cornice material. While the canopy attached to the west façade is an addition post 1967, we recommend retaining this since it serves the purpose of protecting the entry from the elements. However, if the canopy's condition in the future deteriorates the Town of Collbran may consider removing it and not constructing a replacement in order to restore the façade closer to its original form.

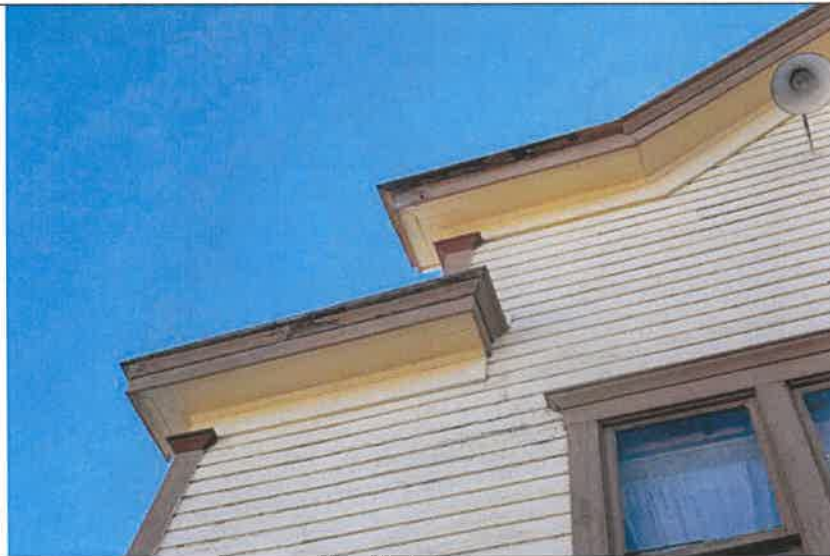
6: West façade – north cornice detail.

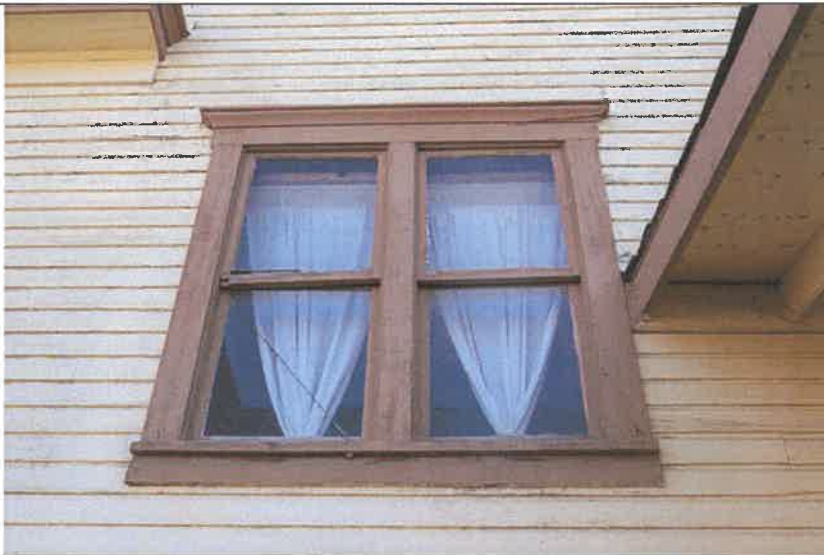
7: West façade – north double hung window set.

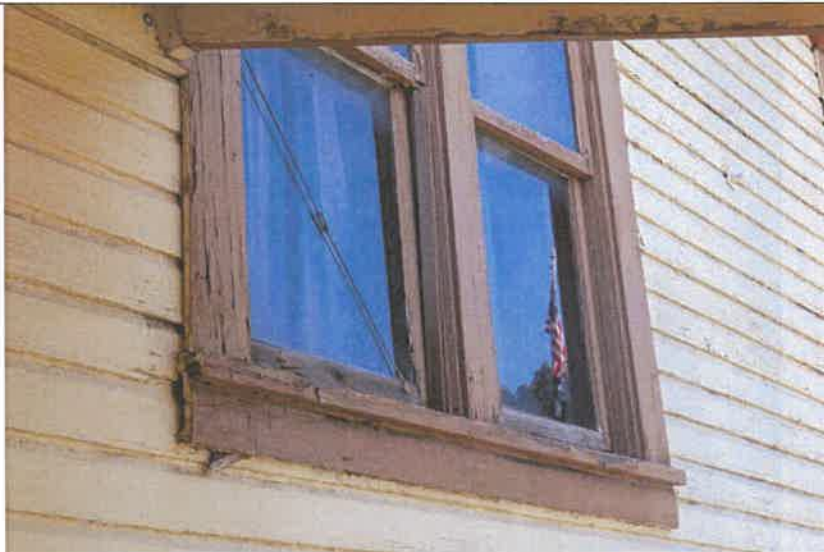
The west façade windows are in poor condition, their exterior trim ranges from fair to poor while the interior trim is in good condition. The windows and trim show signs of rot, cracking and peeling paint (photograph 8).

8: West façade – east double hung window paint peeling and sill degradation.

It is recommended that as much trim material as possible be salvaged for reinstallation. While the condition of the original windows is poor it is recommended that they be re-built to retain as much original fabric as possible. The two south dormer windows that have modern units installed should be replaced with new windows to match the originals in size, material and function, this also applies to any other windows that can not be re-built due to condition.

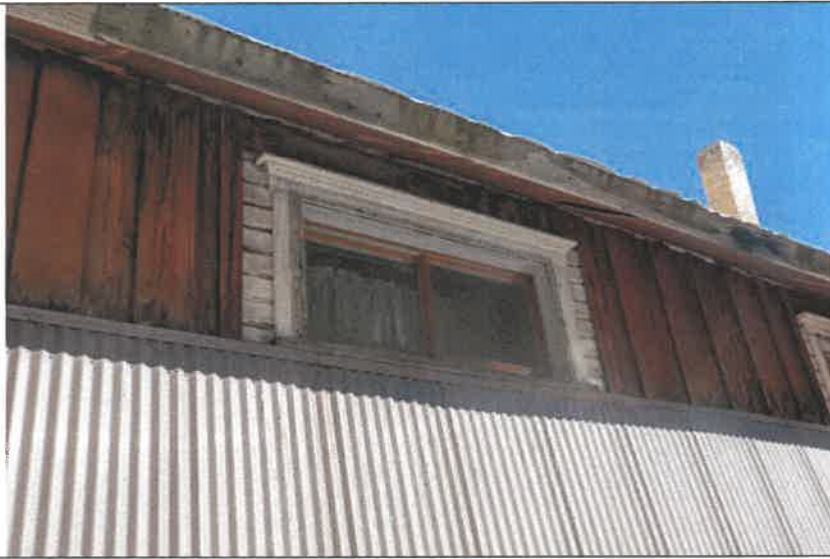
The eight (8) clerestory windows measure 69" wide x 30" tall and are a mix of original awning and replacement sliders (photograph 9). They sit vertically in protrusions from the curving walls with the sides and head soffit areas trimmed with wood paneling. The original clerestory windows have exterior trim consisting of 4" jamb and head sections and a 1-1/2" deep horizontal sloped sill. The replacement windows have exterior trim consisting of a molding head section, 5" jamb trim and a 1" deep horizontal sloped sill. Both original and new

9: South Elevation clerestory window with original drop siding visible.

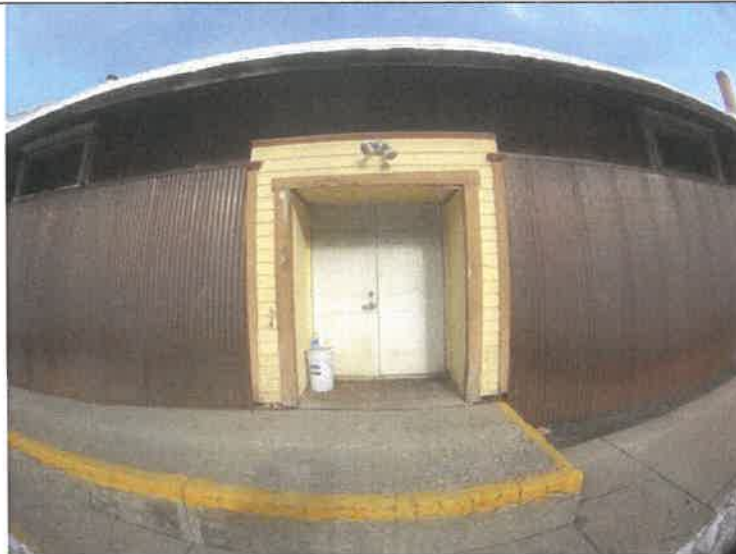
10: South Elevation entry with non ADA compliant ramp.

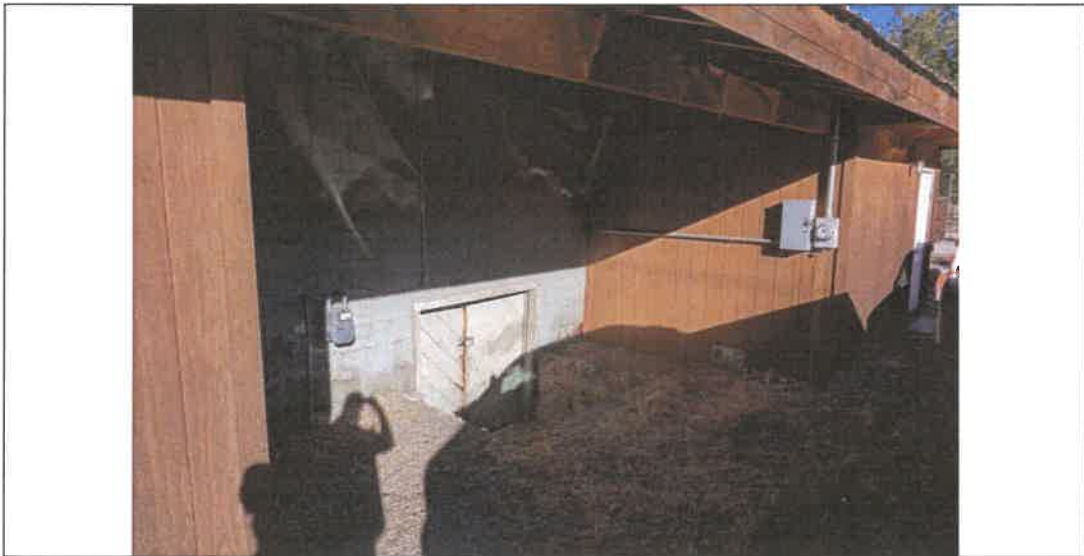
11: East Elevation basement entry, gas meter and electrical panel and meter.

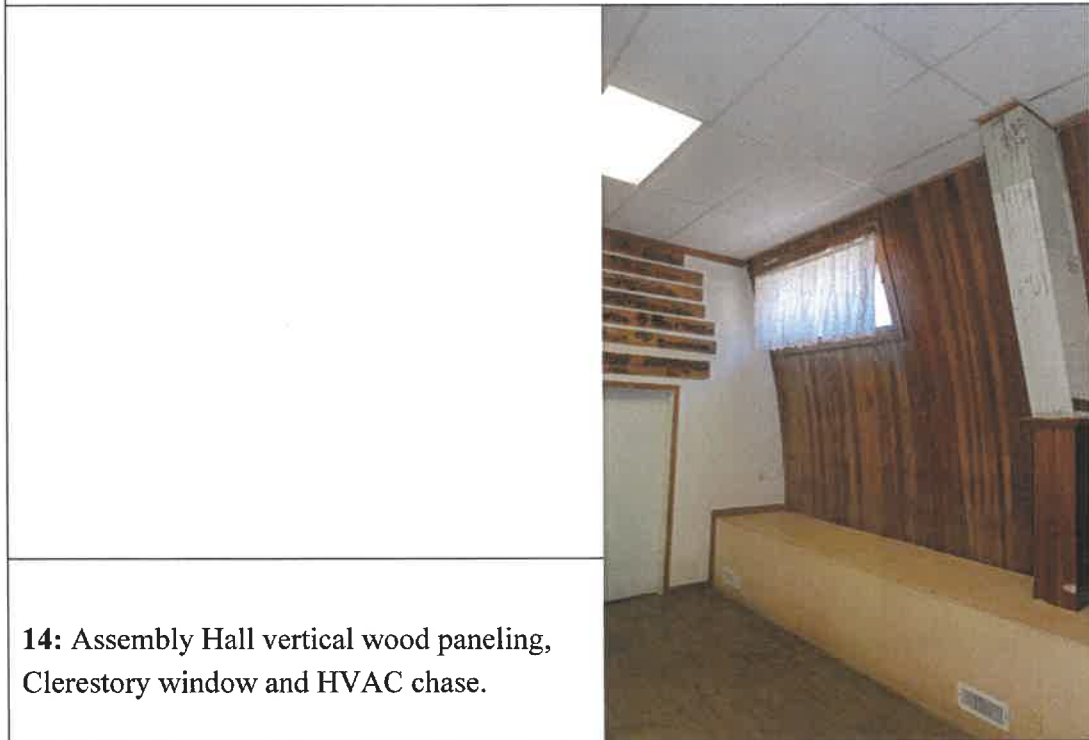
14: Assembly Hall vertical wood paneling, Clerestory window and HVAC chase.

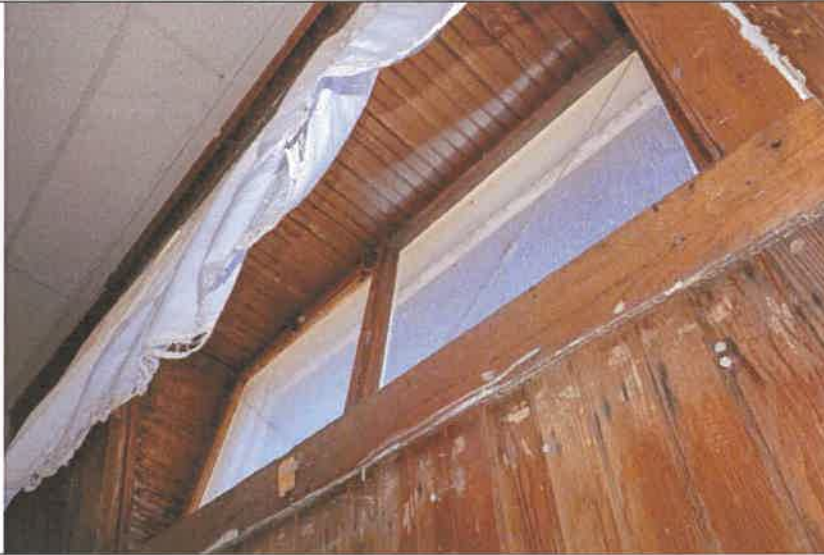
The clerestories are generally all in poor condition. While they all vary in condition some have rot within their structure, others have severe water damage at their head soffit panel sections (photographs 23 & 24).

23: Assembly Hall 104 clerestory window detail.

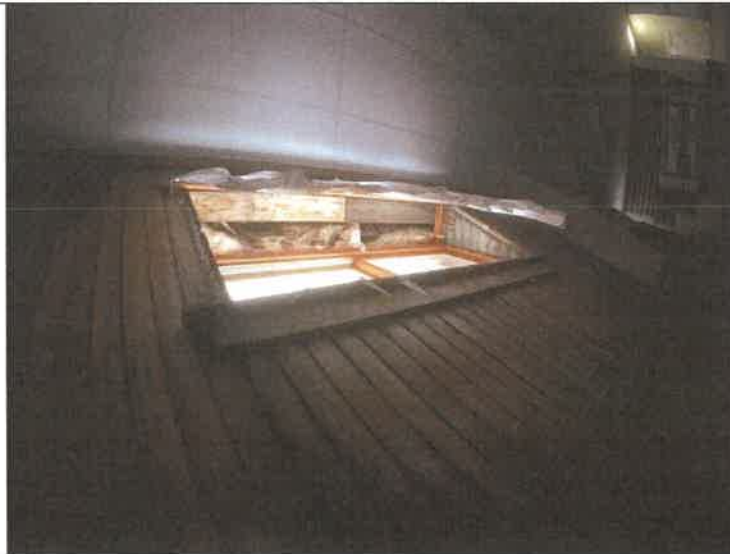
24: Assembly Hall 104 clerestory water damage.

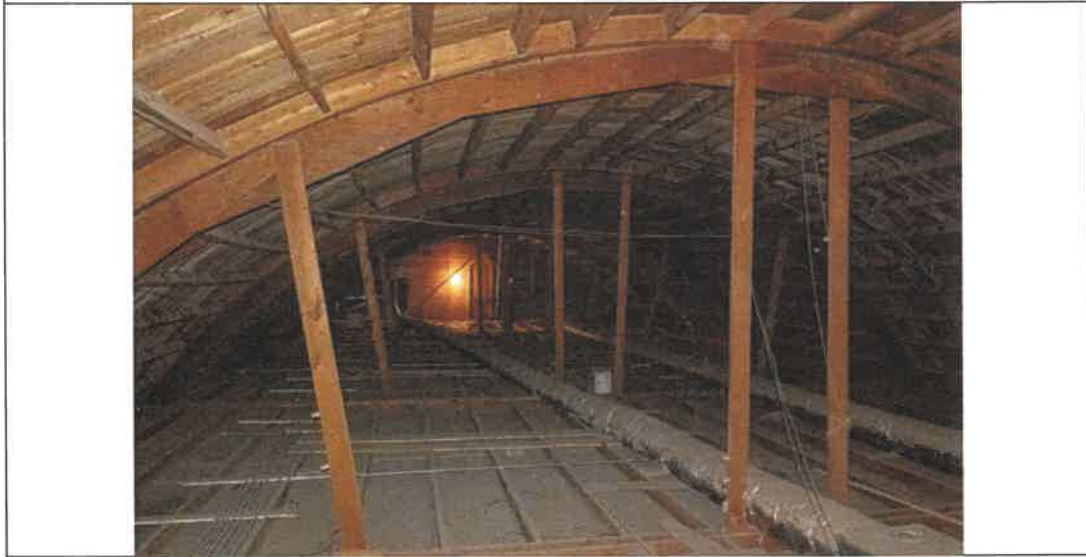
Based upon visual inspection of the attic roof structure there is a significant amount of water damage to the roof decking and girts. The 2x6 girts are undersized given their span of 15' and are visibly bowed. The secondary roof plane overhang above the clerestories is also visibly bowed from presumably being sized inadequately.

30: Attic bow truss roof framing with bowed 2x6 girts spanning between.

All the roof framing should be evaluated further to establish the scope and severity of the water damage. It is expected that only a small number of members will have to be replaced and that the water damage is superficial and be remedied once the roof is made watertight. However, since the girt members appear to be undersized, and load will be added due to snow guard installation that will retain snow, they will need to be either reinforced by sistering additional framing to the existing or by replacing the existing. The existing bow trusses appear to be in good shape.

We recommend that the existing roof be removed, including the wood sheathing. This will allow for the wood grits to be reinforced and new sheathing to be installed. New R-38 batt insulation should be installed in the attic space.

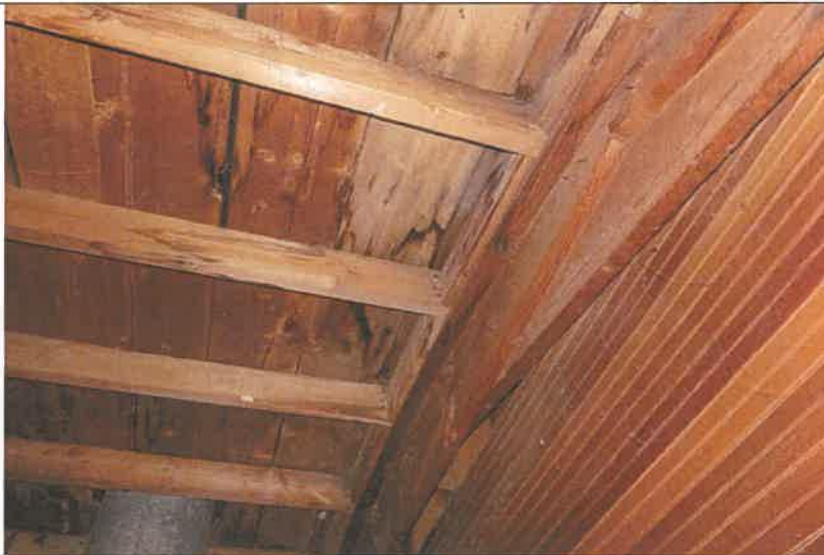
The roofing material is in poor condition and there is clear evidence of water damage to the roof sheathing, girts and heads of the clerestory windows. Most likely water infiltration was a problem in the clerestory vicinity prior to 1967 which prompted the addition of the overhang framing and clerestory infills.

31: Framing at end walls showing deck water damage.

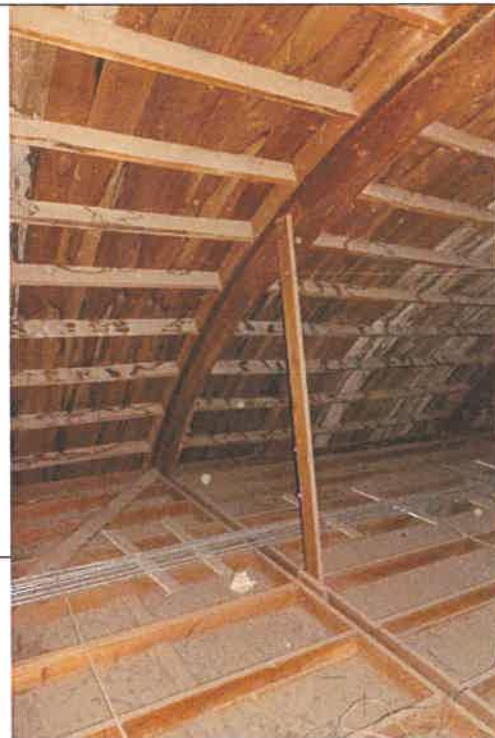
32: Visible water damage on decking and framing.
